## Case study #2 - media organization lobby, United States

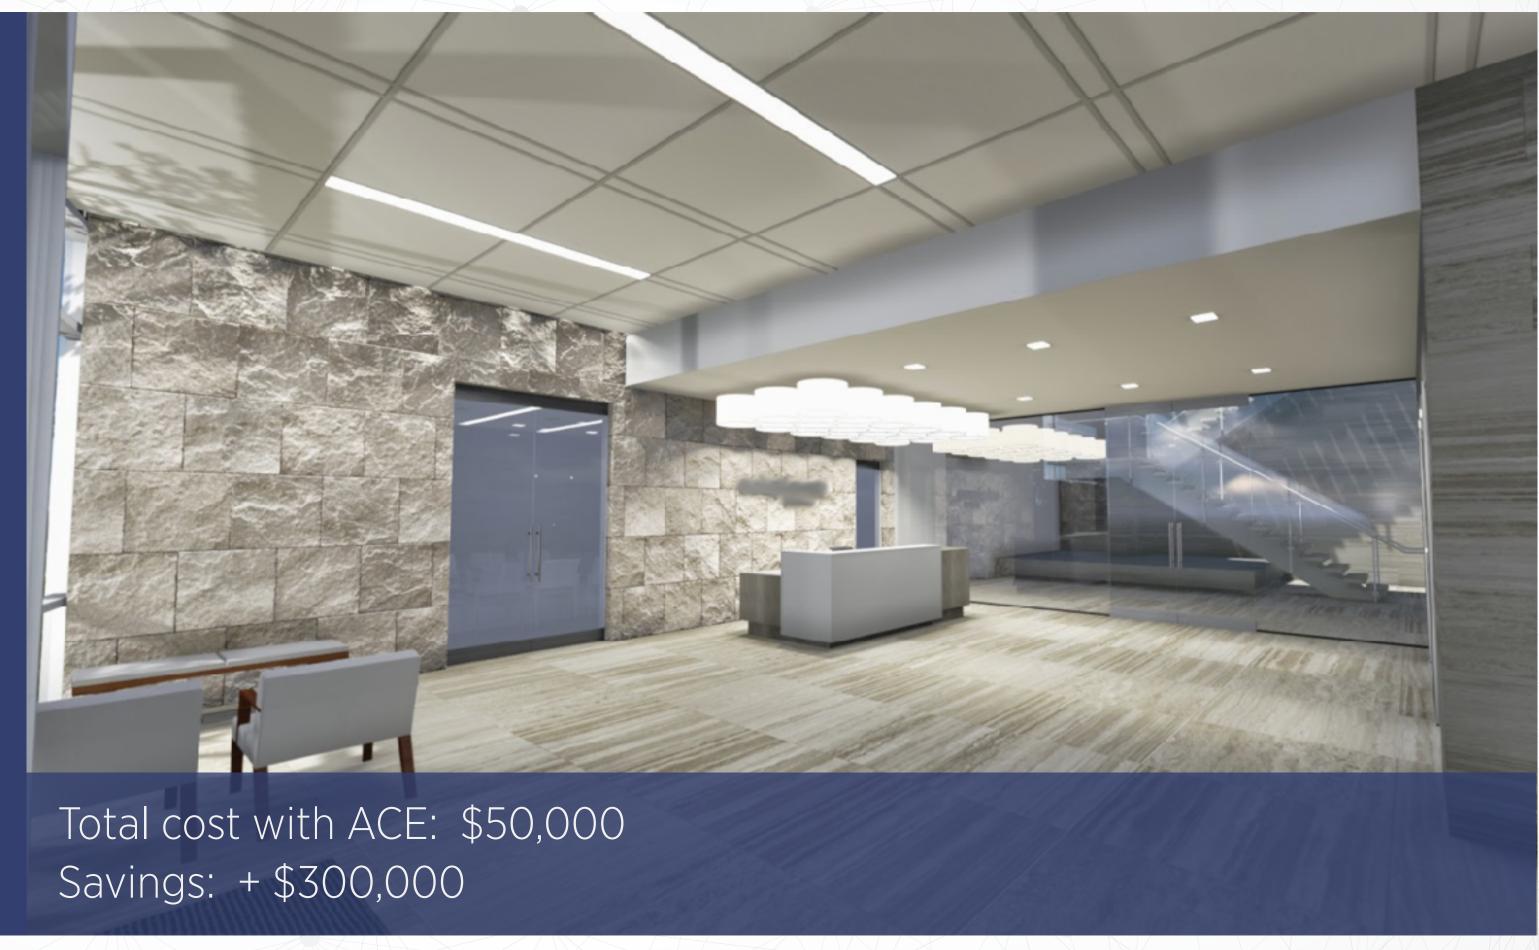
The glass wall featured in the accompanying image was a recent build but was not designed with ballistic capabilities. The cost to remove the glass wall and replace it with a ballistic-hardened glass wall was estimated at \$350,000 - \$400,000.

Artist's rendering. Image is NOT of actual client site.

Using ACE 300 Series security laminates, the existing wall was retrofitted in place to a ballistic rating of UL Level 2 (357 magnum).
